# **EFFECTS OF SURFACE CHEMISTRY ON HOT CORROSION LIFE**

## **FIRST ANNUAL REPORT**

**R.E. Fryxell**

**General Electric Company  
Aircraft Engine Business Group  
Cincinnati, Ohio 45215**

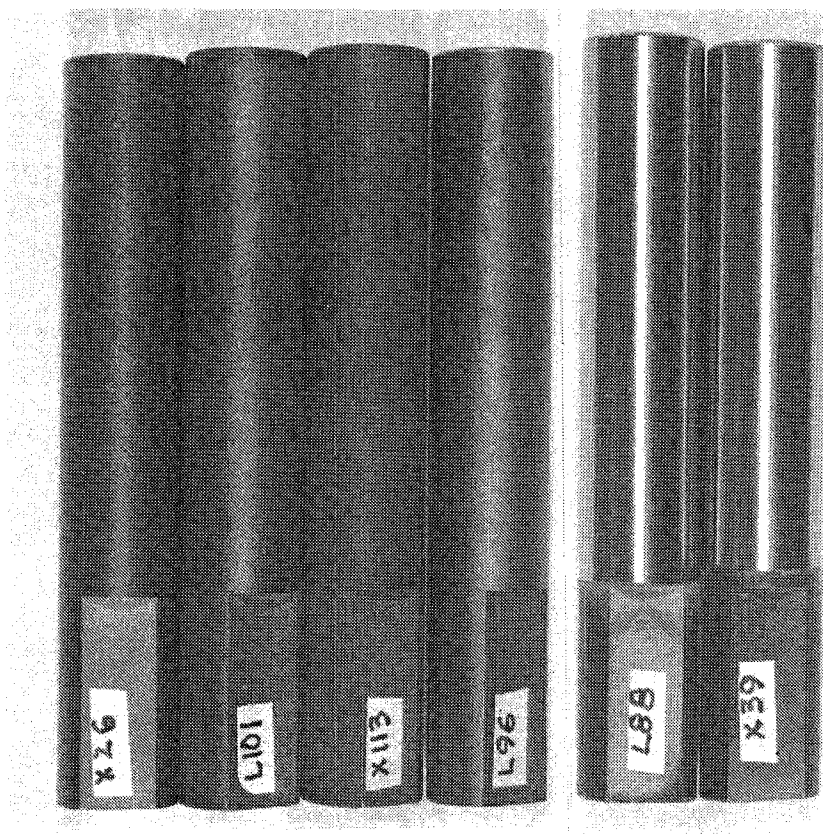
Photographs of typical specimens of all six coating/substrate systems are shown in Figure 14. Photomicrographs are shown in Figure 15; these structures are normal and the two plasma-sprayed coatings exhibit excellent density. Thicknesses of these coatings, including diffusion zone, are:

Figure 14. As-Coated Burner Rig Specimens of Codep, RT21, and NiCoCrAlY to U700 and to René 80 (1.4X).
